## **Full Circle** Shelter in **Puerto Rico**

## **Dennis Fry**

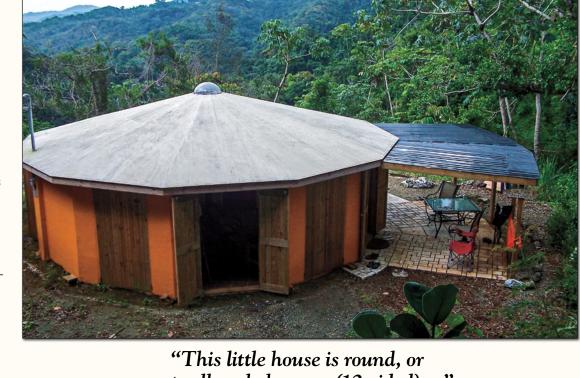
actually a dodecagon (12-sided)..."

This little house is round, or actually a dodecagon (12-sided). The round shape is the strongest shape in a hurricane prone area. The shape is also material- and cost-efficient, requiring less wall area to enclose the same floor space than any other shape. Building as a polygon rather than a true circle allows the easy use of standard commonly available building materials. Each wall is built 5 cement blocks long and 7 blocks high. We used standard 6" blocks with the first course mortared to the floor to establish level. The remainder of the wall blocks are dry stacked with no mortar.
